# Manhole Inspection Summary

Manhole # S170\_\_022MH

**Inspection** ☐ Is Incomplete Rating: **4) Poor**

**Location** Address: **2533 millington-helen alley**

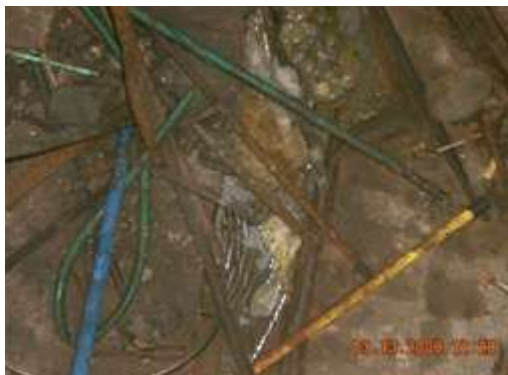
Defect 6

Condition: ☐ Sound ☐ Cracked ☐ Root Intrusion ☐ Deteriorated ☐ Leaks ☒ Debris

debris in channel

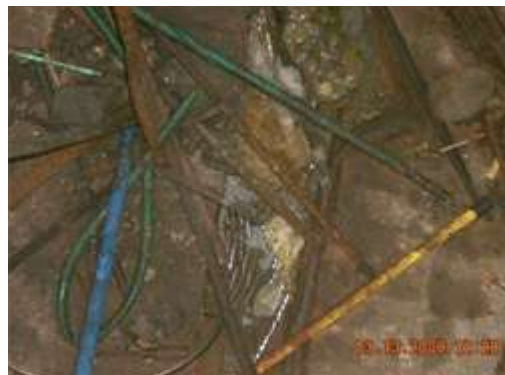
Defect 5

Condition: ☐ Sound ☐ Cracked ☐ Root Intrusion ☐ Deteriorated ☐ Leaks ☒ Debris

debris on bench

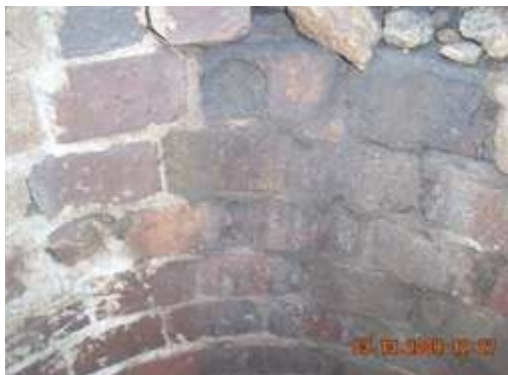
Defect 4

Infiltration: ☐ None ☒ Joint ☐ Cracks ☐ Mortar ☐ Roots ☐ Wall

infiltration @ corbel/chimney joint

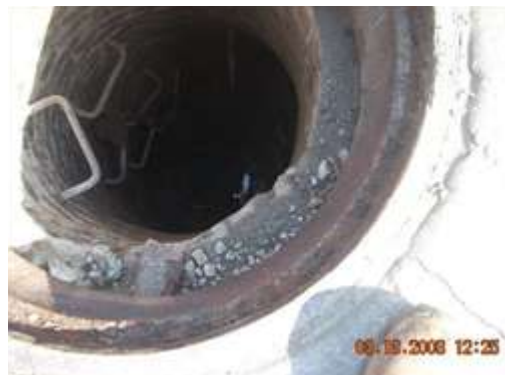
Defect 3

Offset: **2** (in.)

frame offset

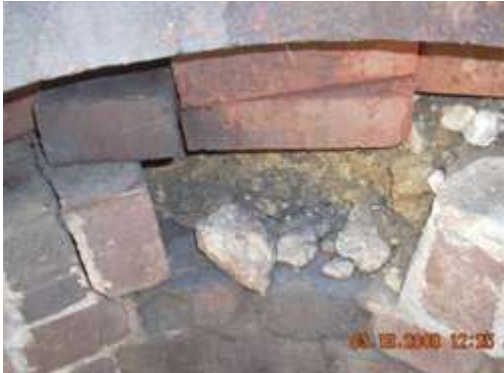
Defect 2

Condition: ☐ Sound ☐ Cracked ☐ Root Intrusion ☐ Loose Brick ☒ Deteriorated

deteriorated corbel bricks

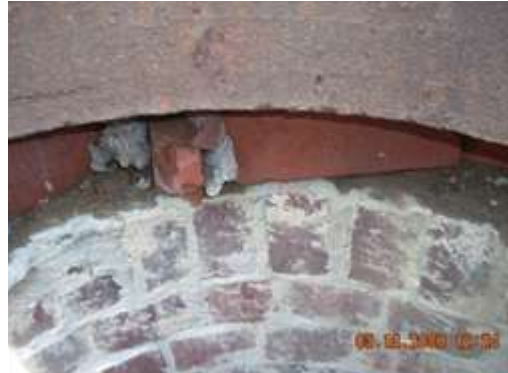
Defect 1

Condition: ☐ Sound ☐ Cracked ☐ Root Intrusion ☒ Loose Brick ☒ Deteriorated

deteriorated and loose chimney bricks

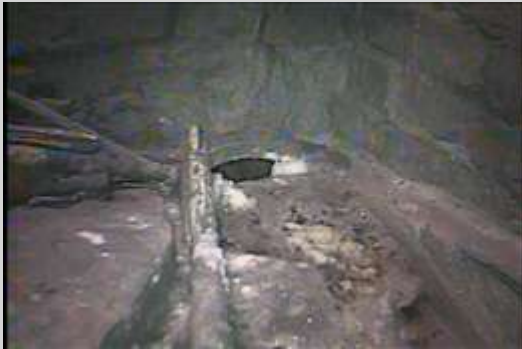
12 O'Clock Outflow

Pipe Height: **8.4** (in.) Rod and Bar (Angled)  
Pipe Material: **Clay** ☐ Pipe Lined  
Invert Depth: **10.40** (ft.) Flow Characteristics: **Slow**  
Deposits: ☐ None ☐ Mud ☐ Sludge ☒ **Debris** ☐ Grease  
Silt Depth: **6** (in.) Deposits Extent: **Heavy**  
Infiltration: **None** Pipe Seal Cond: **Sound**
